**Flood Control Project Maintenance
Levee Inspections**

Fall 2018 Levee Maintenance Deficiency Summary Report

**Flood Control Project Maintenance
Levee Inspections****LMA District Cover Sheet****Fall 2018 Levee Inspection Results****Reclamation District No. 0563 Tyler Island**

Reclamation District No. 0563 Tyler Island

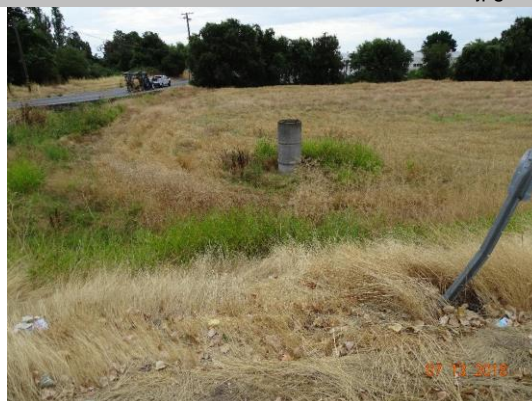
Photo 2 of 3 : UCIP_FA_2018_52739_77710.jpg

LM Start	0.02	Rating **	M	Issue No.	771 (cont)
LM End	0.02	Issue Type +	En	Location *

Standpipe located on LS.

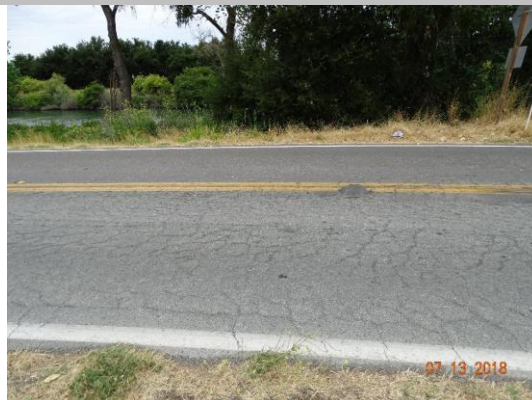
Photo 3 of 3 : UCIP_FA_2018_52739_77711.jpg

View of levee crown at the crossing.

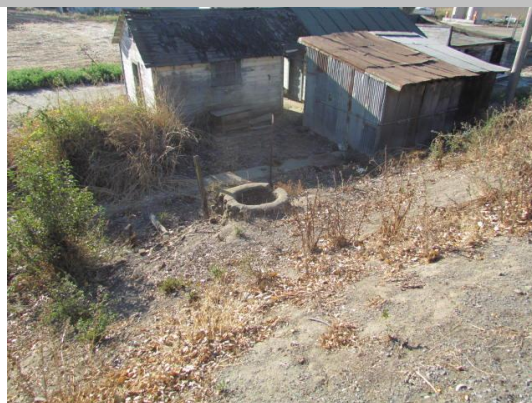
Photo 1 of 3 : FA_2018_RD0563_210_10_20180925_00006.jpg

Looking east at fire pit on landward slope.

LM Start	0.15	Rating **	M	Issue No.	10 (cont)	
LM End	0.15	Issue Type +	En	Location *	LS	
Category	Earthen Levee			GPS Latitude/Longitude		
				Start		End
Item	Encroachments			38.233572 °		38.233572 °
				-121.519083 °		-121.519083 °
DWR ID	DWR_RD0563_01_f_2013_10					
Comment Code						
BU : Building						
Inspector Comment						
Tool shed and fire pit on landward slope and toe.

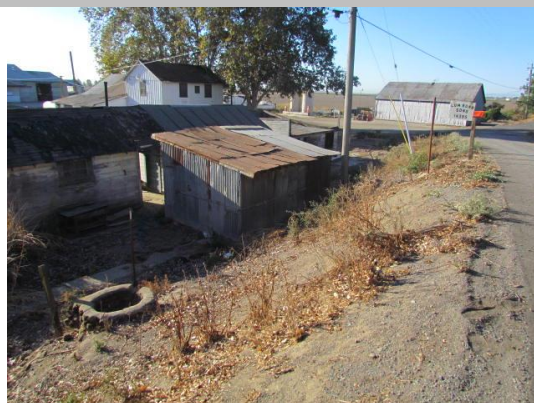
Photo 3 of 3 : FA_2018_RD0563_210_10_20180925_00008.jpg

Looking southeast at storage shed at landward toe.

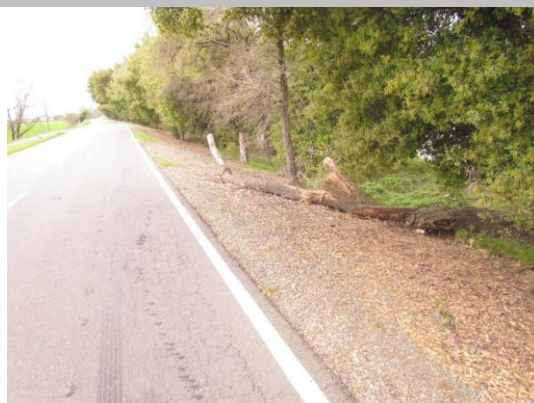
Photo 1 of 2 : FA_2018_RD0563_210_32_20180925_00016.jpg

LM Start	0.17	Rating **	M	Issue No.	32
LM End	0.21	Issue Type +	Ma	Location *	WS
Category	Earthen Levee			GPS Latitude/Longitude	
				Start	End
Item	Encroachments			38.233315 °	38.232887 °
				-121.519360 °	-121.519852 °
DWR ID	DWR_RD0563_01_s_2012_32				
Comment Code					
TR : Tree or limb					
Inspector Comment					
Tree fallen across waterward slope.

Looking downstream at tree branch on waterward slope. (Spring 2017)

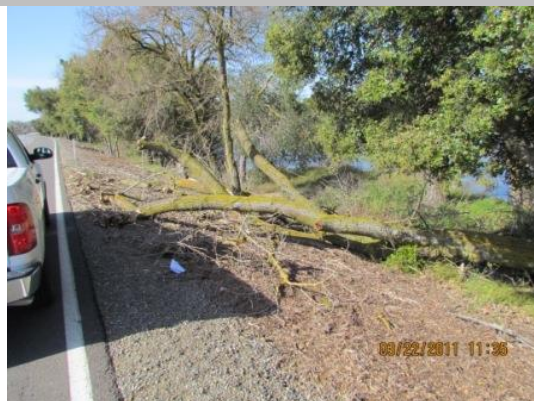
Photo 2 of 2 : FA_2018_RD0563_210_32_20180925_00017.jpg

Looking downstream at fallen tree limb on waterside slope. (Spring 2016)

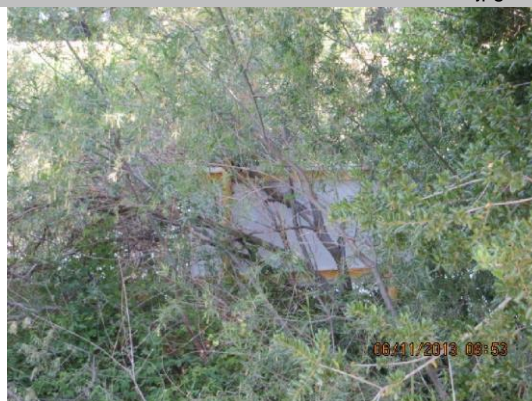
Photo 2 of 3 : UCIP_FA_2018_52740_24504.jpg

Comment Code						
Inspector Comment						
FS_ID:52740						
DS_ID:20129						
EP_NO: 3448						
Repair Type: Non-Urgent						
Crossing Status: Indicator Found						
UCIP Comments: 07/13/2018 Gas pipeline crossing sign found on LS slope, and monitoring well on levee crown. (O.Yakimov-DWR UCIP)6/11/2013 Sign on waterside slope should be cleared of vegetation.						
FIELD_STRUCT_DESC: 4.5-inch steel gas line through the levee, 4 feet below the crown and across the channel. Large warning sign on the waterside (WS) slope. (Permit No. 3448, 1960 - Pacific Gas and Electric Company [PG&E]). [Additional Reference(s): DWR Levee Log, 2005].						
FS Date: 7/13/2018 9:16:16 AM

Gasline warning sign covered in vegetation on WS slope.

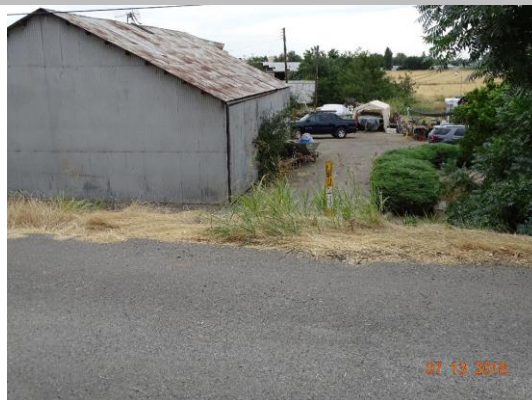
Photo 3 of 3 : UCIP_FA_2018_52740_77712.jpg

Sign on LS slope.

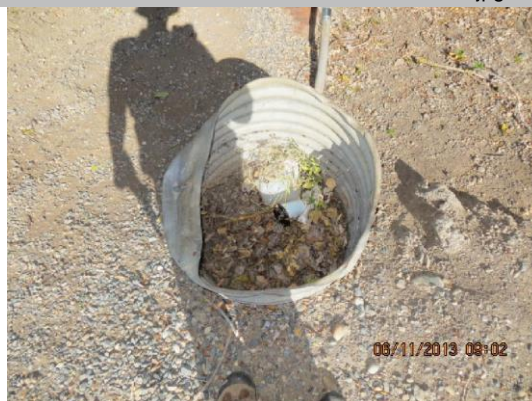
Photo 2 of 3 : UCIP_FA_2018_52741_24507.jpg

Comment Code						
Inspector Comment						
FS_ID:52741 DS_ID:20130 EP_NO: 11218 Repair Type: Non-Urgent Crossing Status: Found UCIP Comments: 07/13/2018 Electrical conduit that is attached to the pipe on WS fell appart at several locations. LS and WS slopes are heavily vegetated. (O.Yakimov-DWR UCIP)06/11/2013 Pipe leaking at various points on WS berm. Failure on berm may indicate potential for failure within the levee. Good candidate for video inspection. (W.Wylie-DWR) FIELD_STRUCT_DESC: 12-inch steel irrigation pipe through the levee, 5 feet below the crown. Walkway to pump on pile structure in stream. Siphon breaker in a 24-inch corrugated metal pipe (CMP) riser on the waterside (WS) shoulder. 1-inch air and vacuum valve and a 15-foot-tall by 36-inch-diameter concrete standpipe at the landside (LS) toe. (Automatic Board Order (ABO) issued as Permit No. 11218, 1975 - Fong Yock Yee). [Additional Reference(s): DWR Levee Log, 2005. USACE Sacramento O&M Manual 103, June 1954, (Station ""L2"" 196+67.8)]. FS Date: 7/13/2018 9:38:39 AM

Siphon breaker not visible in 24-inch CMP riser on WS shoulder.

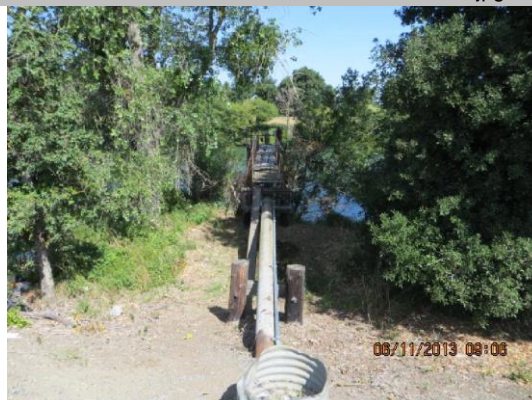
Photo 3 of 3 : UCIP_FA_2018_52741_24509.jpg

Pipe and pier on WS.

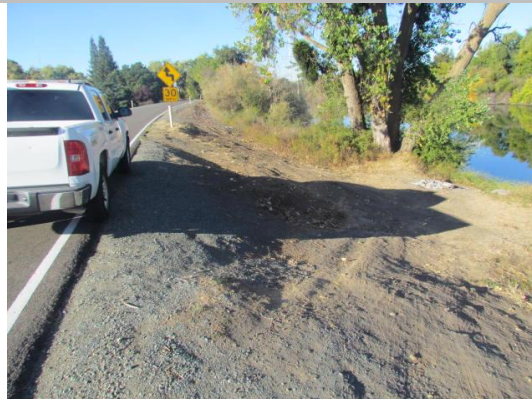
Photo 1 of 2 : FA_2018_RD0563_210_143_20180925_00100.jpg

LM Start	0.56	Rating **	M	Issue No.	143
LM End	0.56	Issue Type +	Ma	Location *	WS
Category	Earthen Levee			GPS Latitude/Longitude	
				Start	End
Item	Slope Stability			38.228930 °	38.228930 °
				-121.523935 °	-121.523935 °
DWR ID	DWR_RD0563_01_f_2014_143				
Comment Code					
S3 : Repair the levee slope damaged by vehicle traffic and prevent access where possible.					
Inspector Comment					
Slope damage due to vehicle traffic.

Looking southeast at slope damage on waterward slope.

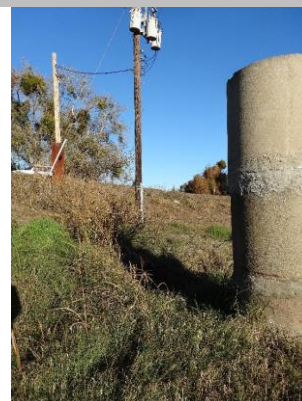
Photo 1 of 3 : UCIP_FA_2018_52731_76821.jpg

FS_ID:52731
DS_ID:20131
EP_NO: 11203
Repair Type: Urgent
Crossing Status: Found
UCIP Comments: 07/13/2018 Dense vegetation on LS slope limits visibility. Crossing remains "Urgent" due to unknown condition of the pipe section through the levee. (O.Yakimov-DWR UCIP) 03/08/2018 LS pipe section replaced however, unable to determine the condition of the pipe section through the levee. LS levee section disurbed and has not been repaired. Crossing remains Urgent due to the unknown condition of the pipe section through the levee. (O. Magana - DWR UCIP)12/02/2016 Same as last inspection signs of leak are still present on both LS and WS. Recommend internal inspection of the pipe integrity though the levee to determine cause of depression on levee (either leak or poor compaction). Pipe debris previous noted on WS has been removed. (O. Magana - DWR UCIP)06/11/2013 Signs of leak in pipe at levee slope on both LS and WS where pipe enters levee. Moist soil at LS toe indicates possible internal leak. Evidence of recent pipe repair on WS. Pipe debris on WS toe should be removed. (W. Wylie - DWR UCIP)

View of LS slope.

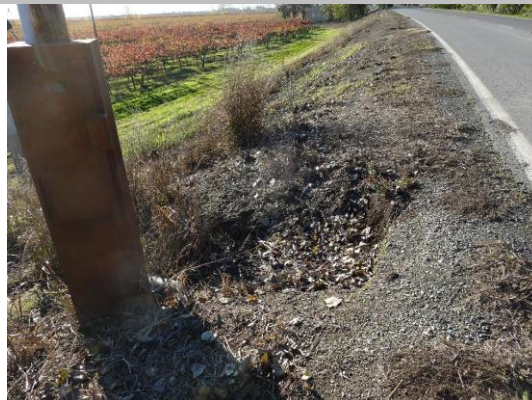
Photo 3 of 3 : UCIP_FA_2018_52731_76826.jpg

UCIP Comments: 07/13/2018 Dense vegetation on LS slope limits visibility. Crossing remains "Urgent" due to unknown condition of the pipe section through the levee. (O.Yakimov-DWR UCIP) 03/08/2018 LS pipe section replaced however, unable to determine the condition of the pipe section through the levee. LS levee section disurbed and has not been repaired. Crossing remains Urgent due to the unknown condition of the pipe section through the levee. (O. Magana - DWR UCIP)12/02/2016 Same as last inspection signs of leak are still present on both LS and WS. Recommend internal inspection of the pipe integrity though the levee to determine cause of depression on levee (either leak or poor compaction). Pipe debris previous noted on WS has been removed. (O. Magana - DWR UCIP)06/11/2013 Signs of leak in pipe at levee slope on both LS and WS where pipe enters levee. Moist soil at LS toe indicates possible internal leak. Evidence of recent pipe repair on WS. Pipe debris on WS toe should be removed. (W. Wylie - DWR UCIP)

Subsidence visible on LS shoulder.

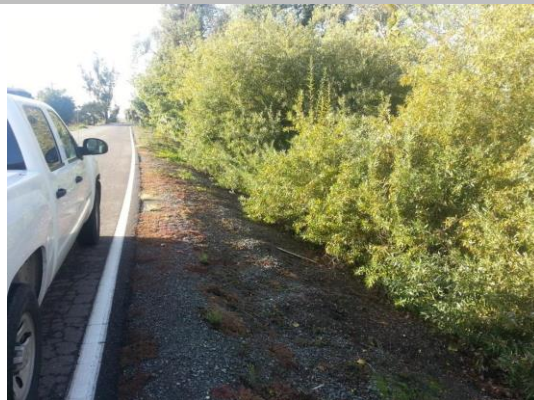
Photo 1 of 2 : FA_2018_RD0563_210_3_20180925_00001.jpg

LM Start	0.73	Rating **	U	Issue No.	3
LM End	0.79	Issue Type +	Ma	Location *	WS
Category	Earthen Levee			GPS Latitude/Longitude	
				Start	End
Item	Trim / Thin Trees			38.227169°	38.226370°
				-121.525892°	-121.525912°
DWR ID	DWR_RD0563_01_s_2012_3				
Comment Code					
T1 : Trim trees to at least five feet above ground level.					
Inspector Comment					
Dense veg on waterward slope.

Looking east at untrimmed trees on waterward slope. (Fall 2016)

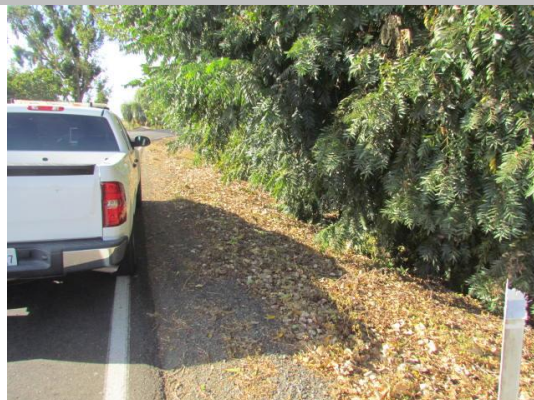
Photo 2 of 2 : FA_2018_RD0563_210_3_20180925_00002.jpg

Looking east at untrimmed trees on waterward slope and toe. (Spring 2016)

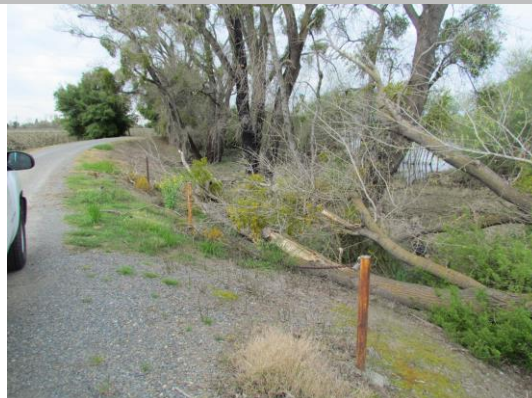
Photo 1 of 1 : FA_2018_RD0563_210_120_20180925_00079.jpg

LM Start	0.88	Rating **	M	Issue No.	120
LM End	0.88	Issue Type +	Ma	Location *	WS
Category	Earthen Levee			GPS Latitude/Longitude	
				Start	End
Item	Encroachments			38.225482 °	38.225482 °
				-121.526882 °	-121.526882 °
DWR ID	DWR_RD0563_01_s_2017_120				
Comment Code					
TR : Tree or limb					
Inspector Comment					
Fallen tree on waterward slope.

Looking southwest at fallen tree on waterward slope.

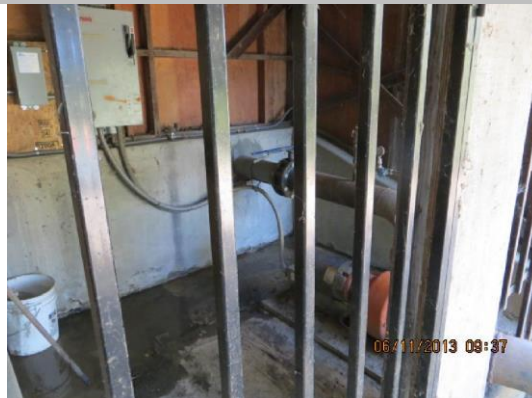
Photo 2 of 3 : UCIP_FA_2018_52744_24515.jpg

Comment Code						
Inspector Comment						
FS_ID:52744 DS_ID:20132 EP_NO: 11210 Repair Type: Non-Urgent Crossing Status: Found UCIP Comments: 07/13/2018 Water pump is running, leak thru pump seal is detected. Pipe on WS has been partially replaced with a new pipe to pumphouse. Remaining part of old pipe needs to be abandoned properly. (O.Yakimov-DWR UCIP)06/11/2013 Pipe does not have sufficient cover at crown. (W.Wylie) FIELD_STRUCT_DESC: 6-inch irrigation pipe of an unknown material through the levee, 3 inches below the crown. Pump and gate valve in pump house on the waterside (WS) slope. Service pole on the landside (LS) slope. (Automatic Board Order (ABO) issued as Permit No. 11210, 1975 - Leland O. Hanson). 1-inch polyvinyl chloride (PVC) electrical conduit through the levee at the same location, at an unknown depth. [Additional Reference(s): DWR Levee Log, 2005. USACE Sacramento O&M Manual 103, June 1954, (Station ""L"" 43+91.9), listed as a 14-inch pipe]. FS Date: 7/13/2018 1:28:34 PM

Butterfly valve, vent and pump in pumphouse on WS shoulder.

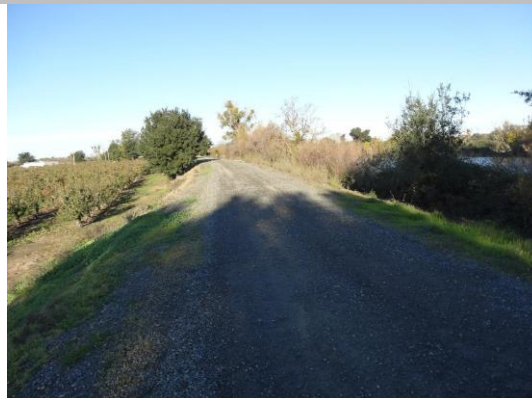
Photo 1 of 3 : UCIP_FA_2018_52745_76827.jpg

View of levee crown at pipe crossing.

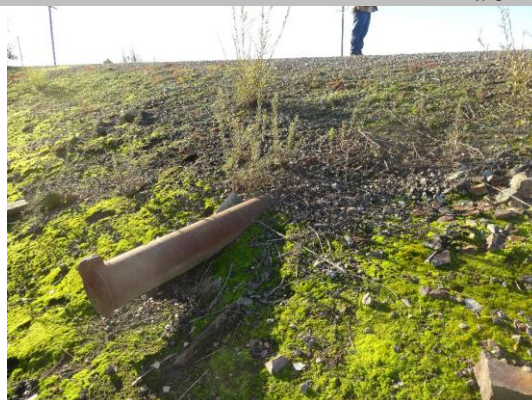
Photo 2 of 3 : UCIP_FA_2018_52745_76828.jpg

Pipe with flap visible on WS.

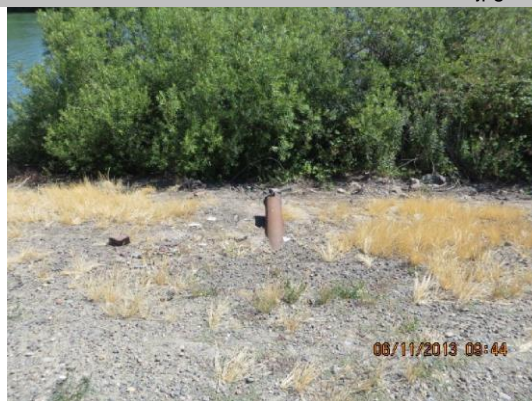
Photo 3 of 3 : UCIP_FA_2018_52745_24524.jpg

Comment Code						
Inspector Comment						
FS_ID:52745 DS_ID:20133 EP_NO: 11210 Repair Type: Non-Urgent Crossing Status: Found UCIP Comments: 07/13/2018 Pipe is open on LS. Same as last inspection. (O.Yakimov-DWR UCIP)12/02/2016 According to LMA representative, Darcy Neuderk, this crossing was installed in 1952 by the USACE and intended to be use for irrigation purposes. However, this crossing has never been used per LMA's knowledge. Crossing has been downgraded from "Urgent" to "Non-Urgent", the flap gate on the WS is functional and prevents any potential flood water from draining to LS. Recommend contacting property owner and working with the CVFPB to address abandoned crossing. (O. Magana - DWR UCIP)06/11/2013 Flap gate rusted in closed position. (W. Wylie - DWR UCIP) FIELD_STRUCT_DESC: 2 of 2: 8-inch steel drainage pipe through the levee, 3 feet below the crown. Flap gate on the waterside (WS). Pipe open on the landside (LS). (8-inch pipe [HLM 0.97] authorized under Automatic Board Order (ABO) issued as Permit No. 11210, 1975 - Leland O. Hanson). [Additional Reference(s): DWR Levee Log, 2005]. FS Date: 7/13/2018 1:40:12 PM

Pipe and flapgate on WS slope.

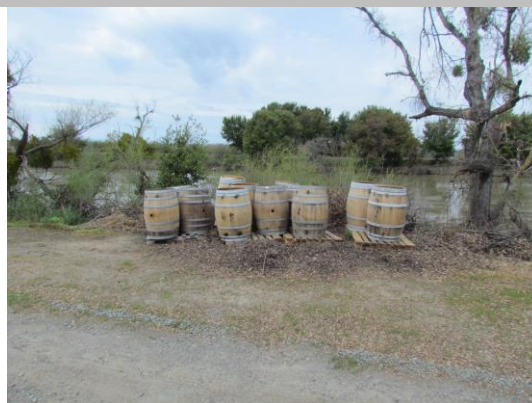
Photo 1 of 2 : FA_2018_RD0563_210_122_20180925_00082.jpg

LM Start	1.18	Rating **	M	Issue No.	122
LM End	1.18	Issue Type +	En	Location *	WS
Category	Earthen Levee			GPS Latitude/Longitude	
				Start	End
Item	Encroachments			38.226737 °	38.226737 °
				-121.531747 °	-121.531747 °
DWR ID	DWR_RD0563_01_s_2017_122				
Comment Code					
GA : Garbage					
Inspector Comment					
Landowner storing prunings on waterside slope.

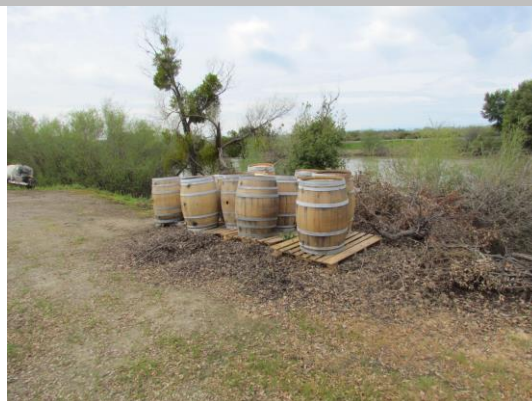
Photo 2 of 2 : FA_2018_RD0563_210_122_20180925_00083.jpg

Looking west at wine barrels and prunings on waterward shoulder and slope.

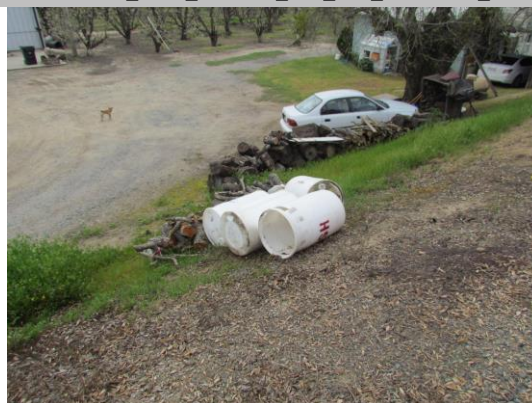
Photo 1 of 2 : FA_2018_RD0563_210_134_20180925_00091.jpg

LM Start	1.21	Rating **	M	Issue No.	134
LM End	1.21	Issue Type +	En	Location *	LS
Category	Earthen Levee			GPS Latitude/Longitude	
				Start	End
Item	Encroachments			38.226462 °	38.226462 °
				-121.532172 °	-121.532172 °
DWR ID	DWR_RD0563_01_s_2016_134				
Comment Code					
FW : Firewood					
Inspector Comment					
Landowner stock piling firewood and other garbage at landward toe.

Looking east at firewood and empty containers on landward slope. (Spring 2017)

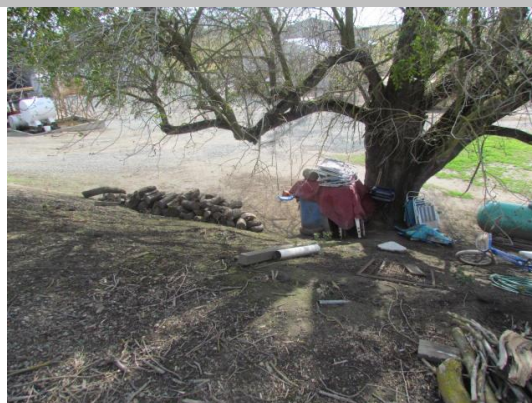
Photo 1 of 2 : FA_2018_RD0563_210_57_20180925_00021.jpg

LM Start	1.22	Rating **	U	Issue No.	57
LM End	1.22	Issue Type +	En	Location *	LS
Category	Earthen Levee			GPS Latitude/Longitude	
				Start	End
Item	Encroachments			38.226345 °	38.226345 °
				-121.532332 °	-121.532332 °
DWR ID	DWR_RD0563_01_s_2012_57				
Comment Code					
BU : Building					
Inspector Comment					
Landowner has built a shed extending from the home onto the levee toe. This unpermitted construction should be removed.

Looking east at firewood and other materials stored on landside slope and toe.

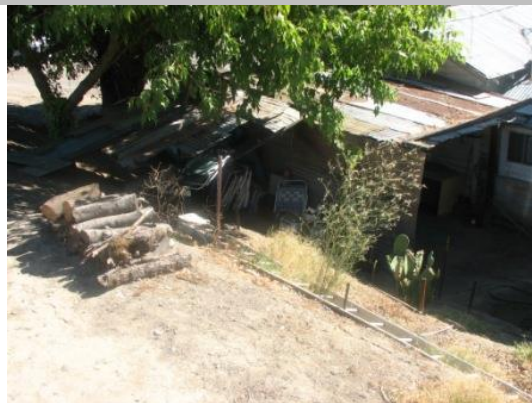
Photo 2 of 2 : FA_2018_RD0563_210_57_20180925_00022.jpg

Looking at a shed at landside toe.

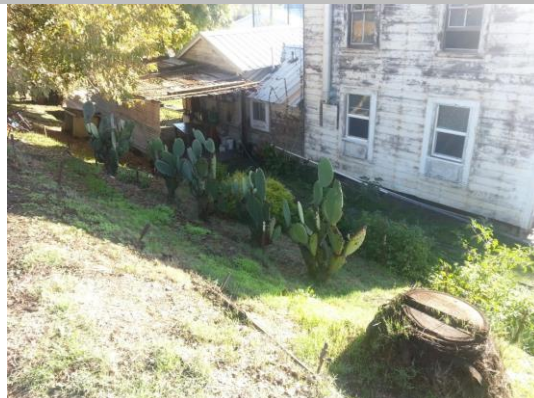
Photo 1 of 2 : FA_2018_RD0563_210_170_20180925_00112.jpg

LM Start	1.22	Rating **	M	Issue No.	170
LM End	1.24	Issue Type +	En	Location *	LS
Category	Earthen Levee			GPS Latitude/Longitude	
				Start	End
Item	Vegetation			38.226316 °	38.226053 °
				-121.532342 °	-121.532525 °
DWR ID	DWR_RD0563_01_f_2016_170				
Comment Code					
V6 : Landscaping					
Inspector Comment					
Remove cactus on landward slope.

Looking southeast at cactus on landward slope.

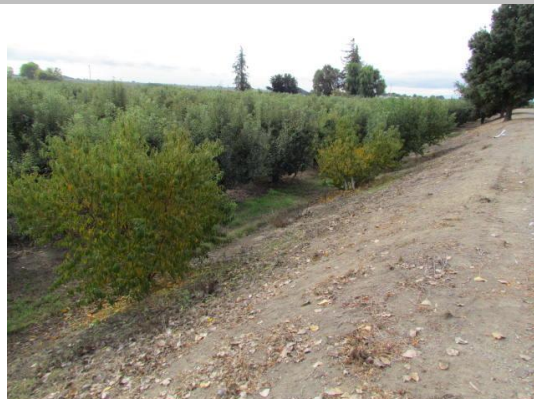
Photo 1 of 1 : FA_2018_RD0563_210_64_20180925_00023.jpg

LM Start	1.27	Rating **	U	Issue No.	64
LM End	1.27	Issue Type +	En	Location *	LS
Category	Earthen Levee			GPS Latitude/Longitude	
				Start	End
Item	Encroachments			38.225730 °	38.225730 °
				-121.532824 °	-121.532824 °
DWR ID	DWR_RD0563_01_f_2012_64				
Comment Code					
CR : Crops					
Inspector Comment					
Fruit trees located at landside toe should be removed.

Looking southeast at fruit trees on landside toe.

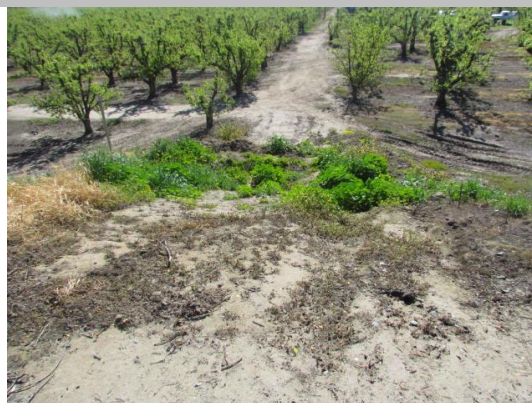
Photo 1 of 3 : FA_2018_RD0563_210_150_20180925_00103.jpg

LM Start	1.35	Rating **	M	Issue No.	150
LM End	1.35	Issue Type +	En	Location *	LS
Category	Earthen Levee			GPS Latitude/Longitude	
				Start	End
Item	Encroachments			38.224817 °	38.224817 °
				-121.533602 °	-121.533602 °
DWR ID	DWR_RD0563_01_s_2016_150				
Comment Code					
RA : Ramp					
Inspector Comment					
Unauthorized ramp on landside slope.

Looking southeast at ramp on landward slope.

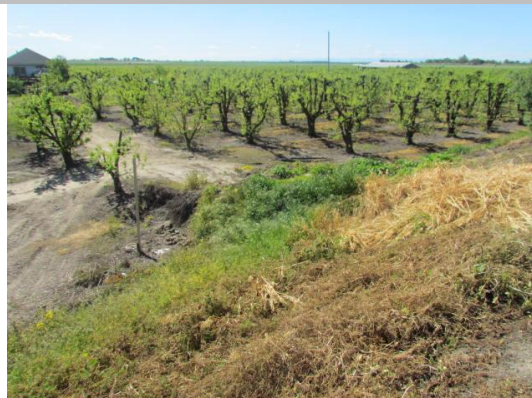
Photo 3 of 3 : FA_2018_RD0563_210_150_20180925_00105.jpg

LM Start	1.35	Rating **	M	Issue No.	150 (cont)	
LM End	1.35	Issue Type +	En	Location *	LS	
Category	Earthen Levee			GPS Latitude/Longitude		
				Start	End	
Item	Encroachments			38.224817 °	38.224817 °	
				-121.533602 °	-121.533602 °	
DWR ID	DWR_RD0563_01_s_2016_150					
Comment Code						
RA : Ramp						
Inspector Comment						
Unauthorized ramp on landside slope.

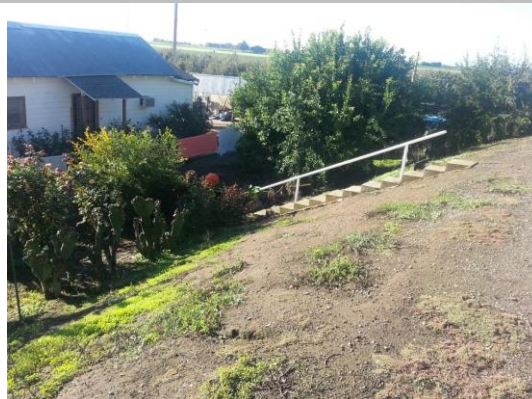
Photo 1 of 1 : FA_2018_RD0563_210_86_20180925_00051.jpg

LM Start	1.39	Rating **	U	Issue No.	86
LM End	1.39	Issue Type +	En	Location *	LS
Category	Earthen Levee			GPS Latitude/Longitude	
				Start	End
Item	Vegetation			38.224351 °	38.224351 °
				-121.534209 °	-121.534209 °
DWR ID	DWR_RD0563_01_f_2013_86				
Comment Code					
V6 : Landscaping					
Inspector Comment					
Landowner has fruit trees and other vegetation on landside slope and toe.

Looking southwest at fruit trees and other plantings at landward toe.

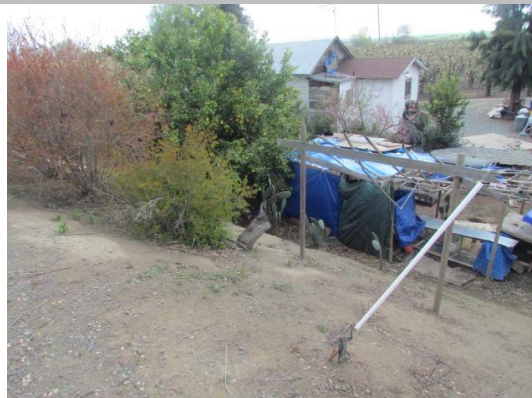
Photo 1 of 3 : FA_2018_RD0563_210_8_20180925_00003.jpg

LM Start	1.40	Rating **	U	Issue No.	8
LM End	1.40	Issue Type +	En	Location *	LS
Category	Earthen Levee			GPS Latitude/Longitude	
				Start	End
Item	Encroachments			38.224315 °	38.224315 °
				-121.534288 °	-121.534288 °
DWR ID	DWR_RD0563_01_s_2012_8				
Comment Code					
BU : Building					
Inspector Comment					
Tool shed, animal storage container, and landscaping on landside slope and toe.

Looking east at landscaping and animal containers on the landside slope and toe.

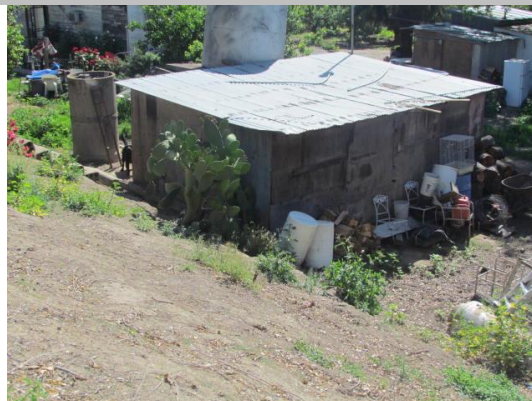
Photo 2 of 3 : FA_2018_RD0563_210_8_20180925_00004.jpg

Looking northeast at a tool shed on the landward toe.

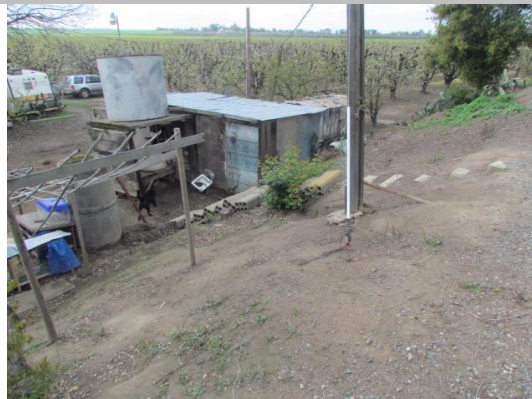
Photo 3 of 3 : FA_2018_RD0563_210_8_20180925_00005.jpg

Looking southeast at a tool shed at the landside toe.

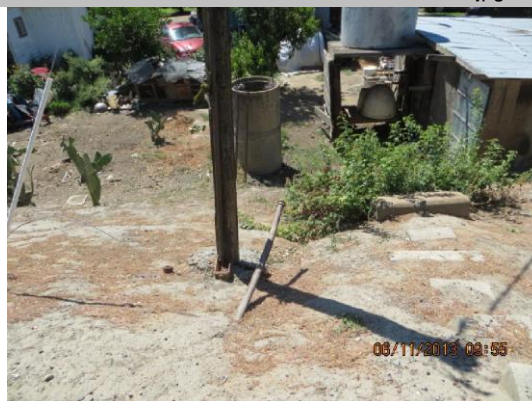
Photo 1 of 3 : UCIP_FA_2018_52747_24527.jpg

LM Start	1.40	Rating **	M	Issue No.	777
LM End	1.40	Issue Type +	En	Location *	
Category	Supplemental			GPS Latitude/Longitude	
				Start	End
Item	DWR UCIP Field Study			38.224302°	38.224302°
				-121.534287°	-121.534287°
DWR ID	20134				
Comment Code					
Inspector Comment					
FS_ID:52747 DS_ID:20134 EP_NO: N/A Repair Type: Non-Urgent Crossing Status: Found UCIP Comments: 07/13/2018 Same as last inspection. (O.Yakimov-DWR UCIP)06/11/2013 Pipe open on LS and should be removed. FIELD_STRUCT_DESC: *ABANDONED* 2-inch electrical conduit of an unknown material through the levee, 2 feet below the crown. [Additional Reference(s): DWR Levee Log, 2005]. FS Date: 7/13/2018 2:34:56 PM

Pipe visible on LS slope at JP.

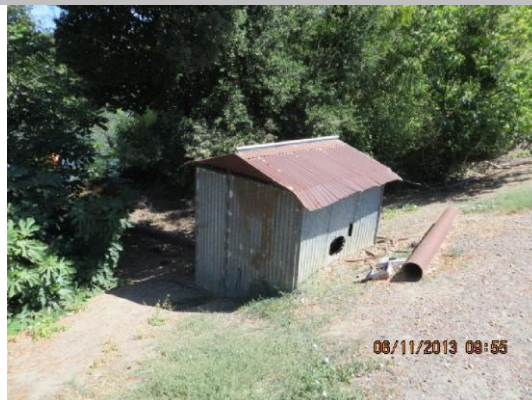
Photo 2 of 3 : UCIP_FA_2018_52747_24526.jpg

Pipe goes to pumphouse on WS slope.

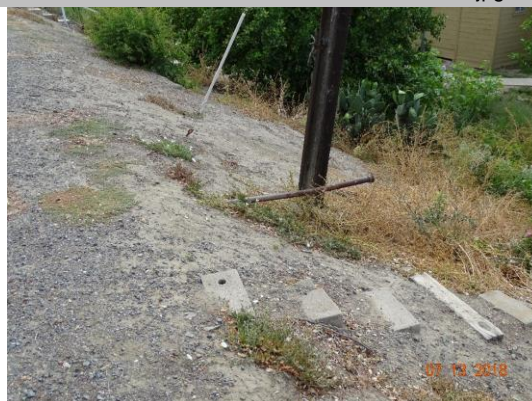
Photo 3 of 3 : UCIP_FA_2018_52747_77727.jpg

View of pipe on LS slope.

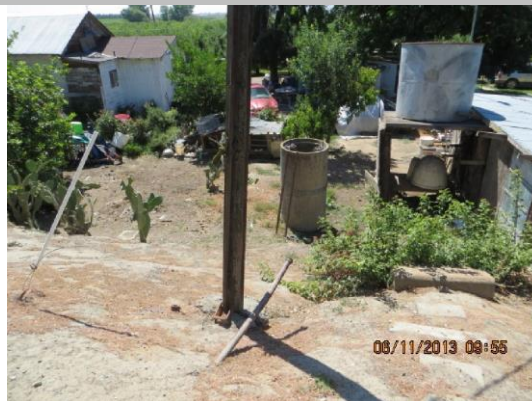
Photo 1 of 3 : UCIP_FA_2018_52748_24530.jpg

Comment Code					
Inspector Comment					
FS_ID:52748 DS_ID:20189 EP_NO: N/A Repair Type: Non-Urgent Crossing Status: Found UCIP Comments: 07/13/2018 Cut-off, abandoned pipe found on riverbank and WS slope next to the irrigation pipe. Old pipe needs to be properly abandoned. (O.Yakimov-DWR UCIP) FIELD_STRUCT_DESC: 8-inch steel irrigation pipe through the levee, 3.1 feet below the crown. 9-foot-tall by 36-inch-diameter concrete standpipe on the landside (LS) toe. 6-foot by 6-foot corrugated metal pump house with pump and butterfly valve on the waterside (WS). 1-inch galvanized iron electrical conduit through the levee at the same location, at an unknown depth. [Additional Reference(s): USACE Sacramento O&M Manual 103, June 1954, (Station ""L2"" 146+62.8)]. FS Date: 7/13/2018 2:47:32 PM

36-inch concrete standpipe on LS toe.

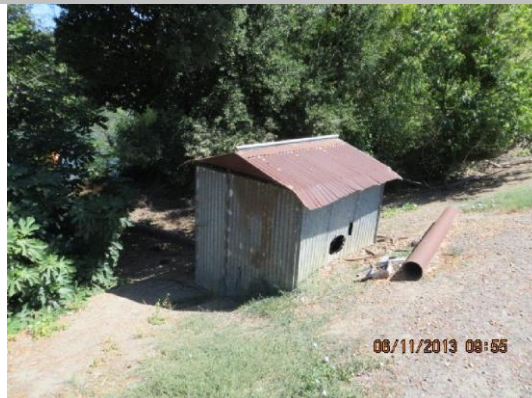
Photo 2 of 3 : UCIP_FA_2018_52748_24529.jpg

Pumphouse on WS slope.

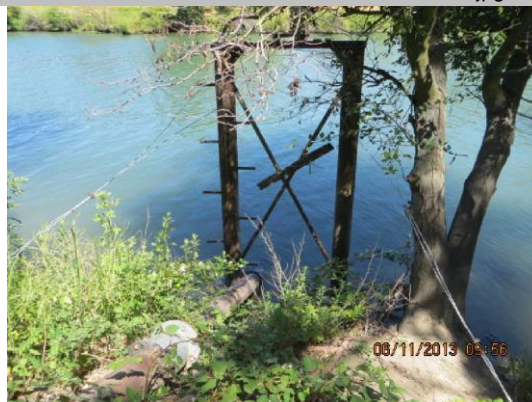
Photo 3 of 3 : UCIP_FA_2018_52748_24528.jpg

Pipe at WS toe.

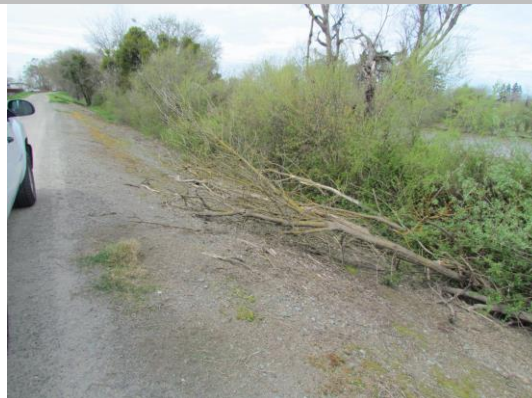
Photo 1 of 1 : FA_2018_RD0563_210_123_20180925_00084.jpg

LM Start	1.69	Rating **	M	Issue No.	123
LM End	1.69	Issue Type +	Ma	Location *	WS
Category	Earthen Levee			GPS Latitude/Longitude	
				Start	End
Item	Encroachments			38.223110 °	38.223110 °
				-121.539495 °	-121.539495 °
DWR ID	DWR_RD0563_01_s_2017_123				
Comment Code					
TR : Tree or limb					
Inspector Comment					
Fallen tree on waterside slope.

Looking south at fallen tree on waterward slope.

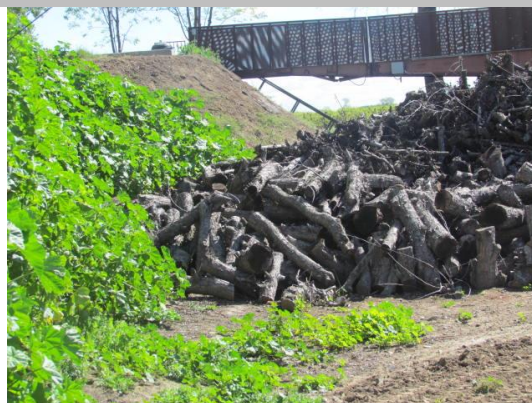
Photo 1 of 1 : FA_2018_RD0563_210_161_20180925_00109.jpg

LM Start	1.82	Rating **	M	Issue No.	161
LM End	1.82	Issue Type +	En	Location *	LS
Category	Earthen Levee			GPS Latitude/Longitude	
				Start	End
Item	Encroachments			38.222768 °	38.222768 °
				-121.541837 °	-121.541837 °
DWR ID	DWR_RD0563_01_f_2018_161				
Comment Code					
FW : Firewood					
Inspector Comment					
Landowner stocking firewood at landside toe.

Looking north at firewood at landward toe.

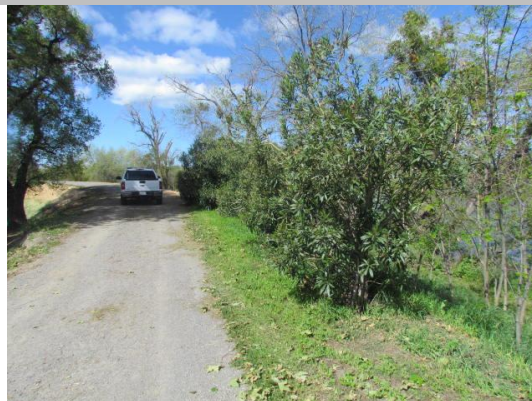
Photo 1 of 4 : FA_2018_RD0563_210_142_20180925_00096.jpg

LM Start	1.86	Rating **	M	Issue No.	142
LM End	1.87	Issue Type +	En	Location *	WS
Category	Earthen Levee			GPS Latitude/Longitude	
				Start	End
Item	Vegetation			38.222743 °	38.222720 °
				-121.542523 °	-121.542741 °
DWR ID	DWR_RD0563_01_s_2014_142				
Comment Code					
V6 : Landscaping					
Inspector Comment					
Landowner has planted oleander on waterside shoulder.

Looking southwest at oleanders on landward shoulder.

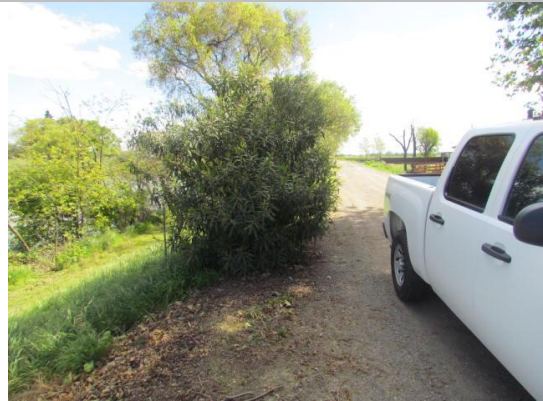
Photo 2 of 4 : FA_2018_RD0563_210_142_20180925_00097.jpg

Looking north at oleanders on landward shoulder.

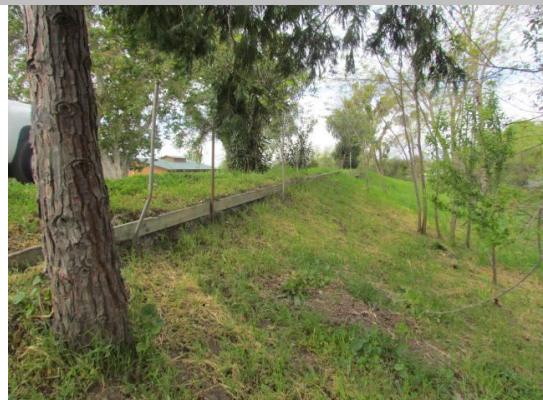
Photo 3 of 4 : FA_2018_RD0563_210_142_20180925_00098.jpg

Looking southeast at planting box on waterward shoulder.

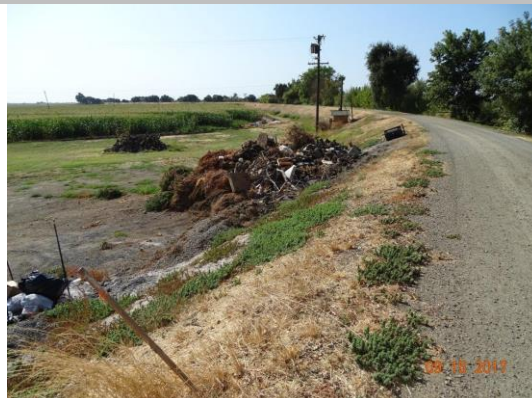
Photo 1 of 1 : FA_2018_RD0563_210_157_20180925_00108.jpg

LM Start	1.94	Rating **	U	Issue No.	157
LM End	1.94	Issue Type +	En	Location *	LS
Category	Earthen Levee			GPS Latitude/Longitude	
				Start	End
Item	Encroachments			38.222080 °	38.222080 °
				-121.543445 °	-121.543445 °
DWR ID	DWR_RD0563_01_f_2015_157				
Comment Code					
GA : Garbage					
Inspector Comment					
Landowner stockpiling garbage at landside toe.

Looking south at the garbage on the landside toe.

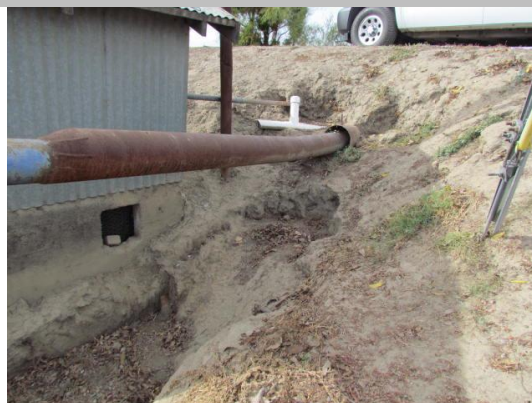
Photo 1 of 2 : FA_2018_RD0563_210_71_20180925_00028.jpg

LM Start	1.95	Rating **	M	Issue No.	71
LM End	1.95	Issue Type +	Ma	Location *	LS
Category	Earthen Levee			GPS Latitude/Longitude	
				Start	End
Item	Erosion / Bank Caving			38.221826 °	38.221826 °
				-121.543467 °	-121.543467 °
DWR ID	DWR_RD0563_01_f _ 2012_71				
Comment Code					
E1 : Note and monitor erosion site.					
Inspector Comment					
Erosion around irrigation pump house and pipe on landside slope.

Looking west at erosion at landside toe and slope next to pump house.

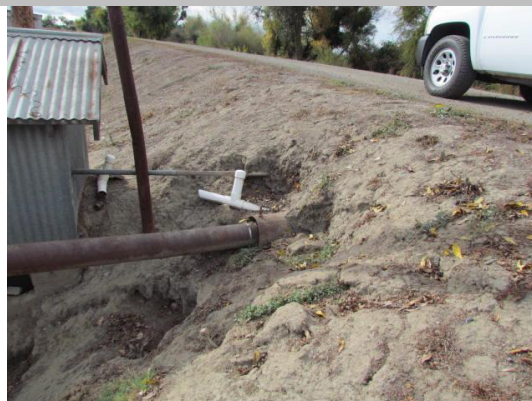
Photo 2 of 2 : FA_2018_RD0563_210_71_20180925_00029.jpg

Looking southwest at erosion around irrigation pipe on landside slope and toe.

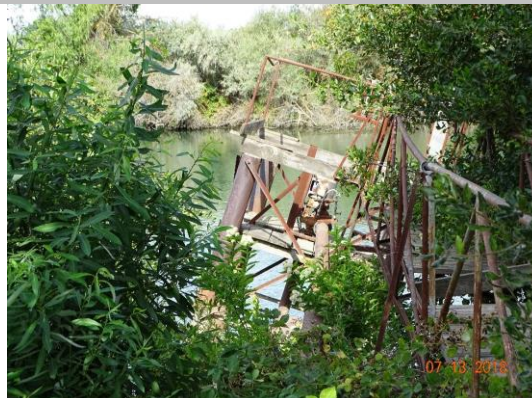
Photo 2 of 3 : UCIP_FA_2018_52751_77735.jpg

Comment Code						
Inspector Comment						
FS_ID:52751 DS_ID:20136 EP_NO: 11204 Repair Type: Non-Urgent Crossing Status: Found UCIP Comments: 07/13/2018 No change from previous inspection. Damaged walkway and tilted pump platform on WS. (O.Yakimov-DWR UCIP)12/02/2016 same as last inspection. Crossing has been downgraded from "Urgent" to "Non-Urgent" no signs of leaks were visible from the surface. Owner will need to coordinate with the CVFPB to comply with Title 23 regarding the sleeved pipe and the non-annular space between the larger and smaller pipe. (O. Magana - DWR UCIP)06/11/2013 Annular space not grouted between 8-inch and 10-inch pipe and the metal walkway is structurally failing. (W. Wylie - DWR UCIP) FIELD_STRUCT_DESC: 8-inch steel irrigation pipe sleeved through a 10-inch pipe (12-inch referenced in permit recordation) through the levee, 4 feet below the crown. 1.5-inch electrical conduit of an unknown material through the levee at the same location, at an unknown depth. Pump on pile structure on the waterside (WS). Timber walkway to pump on the WS. Service pole on the landside (LS) slope. Siphon breaker on the WS slope (12-inch pipe owner name change issued under Permit No. 11204-1, 2015 - Jim Morris. 12-inch pipe [HLM 1.99] authorized under Automatic Board Order (ABO) issued as Permit No. 11204, 1975 - Jim Morris). [Additional Reference(s): DWR Levee Log, 2005. USACE Sacramento O&M Manual 103, June 1954, (Station ""L"" 119+16), listed as a 16-inch pipe]. FS Date: 7/13/2018 8:21:03 AM

Tilted pump platform on WS.

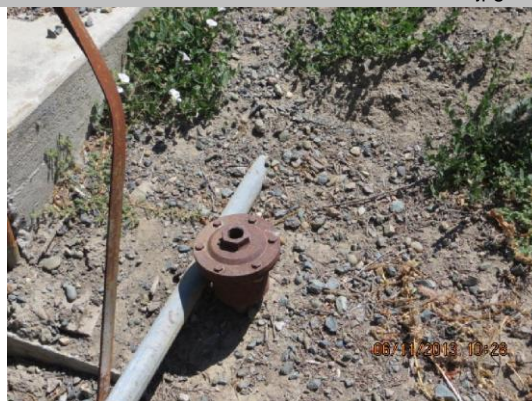
Photo 3 of 3 : UCIP_FA_2018_52751_24536.jpg

Siphon breaker and 1.5-inch galvanized iron electrical conduit.

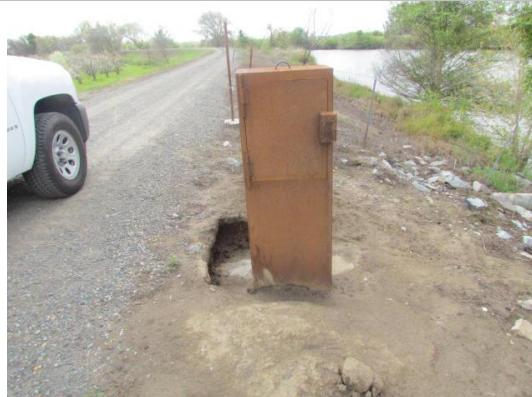
Photo 1 of 1 : FA_2018_RD0563_210_15_20180925_00009.jpg

LM Start	2.18	Rating **	M	Issue No.	15
LM End	2.18	Issue Type +	En	Location *	WS
Category	Earthen Levee			GPS Latitude/Longitude	
				Start	End
Item	Encroachments			38.218575 °	38.218575 °
				-121.542668 °	-121.542668 °
DWR ID	DWR_RD0563_01_s_2012_15				
Comment Code					
EQ : Equipment					
Inspector Comment					
Landowner installed metal box around siphon breaker.

Looking south at siphon box installed on waterside shoulder.

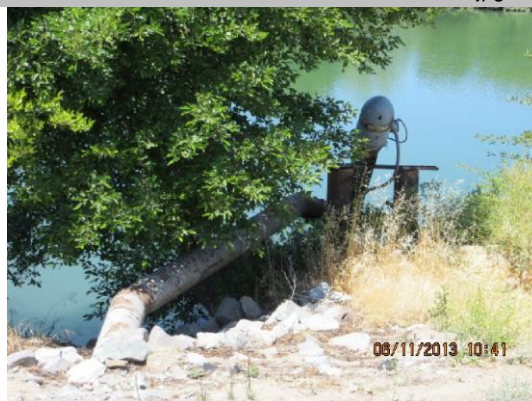
Photo 1 of 3 : UCIP_FA_2018_52732_24541.jpg

Comment Code						
Inspector Comment						
FS_ID:52732 DS_ID:20176 EP_NO: 13311 Repair Type: Urgent Crossing Status: Found UCIP Comments: 07/13/2018 Leak seems to be fixed by the owner by installing steel clamps at pipe join above the standpipe, although could not verify if leak stopped. Site is still vegetated. Crossing remains "Urgent" due to unknown condition of the pipe section through the levee. (O.Yakimov-DWR UCIP)12/02/2016 Dense vegetation around concrete standpipe located on LS toe assume issue recorded back in 2013 is still present due to the dense vegetation around structure. Need to contact owner. Owner will need to coordinate with the CVFPB to address the leaky concrete standpipe and the new metal case installed on WS slope (section of levee still opened). (O. Magana - DWR UCIP)06/11/2013 Concrete standpipe on LS toe is not functioning properly. Leaks springing up in the ground around the standpipe. This may erode the soil at base of levee. (W. Wylie - DWR UCIP) FIELD_STRUCT_DESC: 12-inch steel irrigation pipe through levee, 3 feet below the crown. Slant pump is located on the waterside (WS) toe. 36-inch concrete standpipe and pipe works visible on the landside (LS) toe. Siphon breaker in 24-inch corrugated metal pipe (CMP) riser located on the LS shoulder. Pipe replaced 12-inch pipe from O&M manual/Permit No. 11207. (Permit No. 13311, 1982). (12-inch replaced under Permit No. 13311, 1981 - P. L. Lykins Ranch; 12-inch pipe authorized under Automatic Board Order (ABO) issued as Permit No. 11207, 1975 - Fong) FS Date: 7/13/2018

Slant pump and pipe on WS slope.

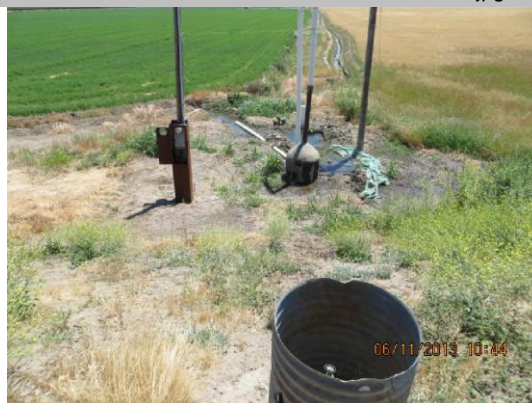
Photo 2 of 3 : UCIP_FA_2018_52732_24540.jpg

UCIP Comments: 07/13/2018 Leak seems to be fixed by the owner by installing steel clamps at pipe join above the standpipe, although could not verify if leak stopped. Site is still vegetated. Crossing remains "Urgent" due to unknown condition of the pipe section through the levee. (O.Yakimov-DWR UCIP)12/02/2016 Dense vegetation around concrete standpipe located on LS toe assume issue recorded back in 2013 is still present due to the dense vegetation around structure. Need to contact owner. Owner will need to coordinate with the CVFPB to address the leaky concrete standpipe and the new metal case installed on WS slope (section of levee still opened). (O. Magana - DWR UCIP)06/11/2013 Concrete standpipe on LS toe is not functioning properly. Leaks springing up in the ground around the standpipe. This may erode the soil at base of levee. (W. Wylie - DWR UCIP) FIELD_STRUCT_DESC: 12-inch steel irrigation pipe through levee, 3 feet below the crown. Slant pump is located on the waterside (WS) toe. 36-inch concrete standpipe and pipe works visible on the landside (LS) toe. Siphon breaker in 24-inch corrugated metal pipe (CMP) riser located on the LS shoulder. Pipe replaced 12-inch pipe from O&M manual/Permit No. 11207. (Permit No. 13311, 1982). (12-inch replaced under Permit No. 13311, 1981 - P. L. Lykins Ranch; 12-inch pipe authorized under Automatic Board Order (ABO) issued as Permit No. 11207, 1975 - Fong)

Concrete standpipe, and 24-inch CMP riser on LS of levee.

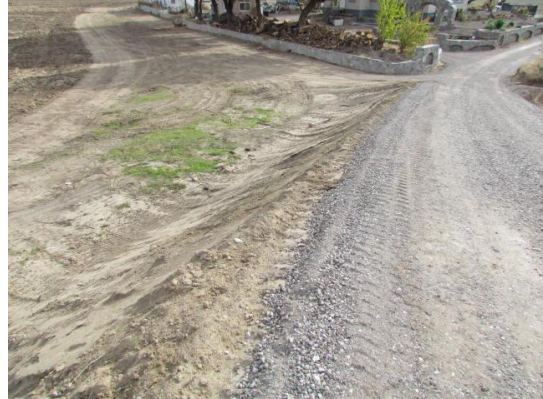
Photo 1 of 2 : FA_2018_RD0563_210_80_20180925_00049.jpg

LM Start	2.57	Rating **	M	Issue No.	80
LM End	2.57	Issue Type +	En	Location *	LS
Category	Earthen Levee			GPS Latitude/Longitude	
				Start	End
Item	Encroachments			38.214707 °	38.214707 °
				-121.538061 °	-121.538061 °
DWR ID	DWR_RD0563_01_f_2012_80				
Comment Code					
RA : Ramp					
Inspector Comment					
Landowner installed unauthorized ramp on landside slope. This ramp is not part of permit # 9146.

Looking east at unauthorized ramp on landside slope.

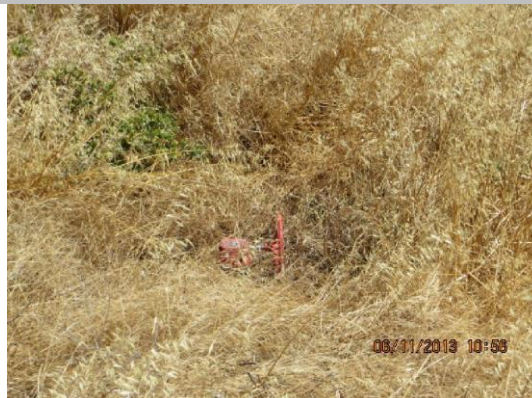
Photo 1 of 3 : UCIP_FA_2018_52753_24545.jpg

Comment Code						
Inspector Comment						
FS_ID:52753 DS_ID:20138 EP_NO: 9146 Repair Type: Non-Urgent Crossing Status: Found UCIP Comments: 07/13/2018 LS levee slope was disturbed to install a closure device and never backfilled. Debris of broken concrete and PVC pipe on LS slope. (O.Yakimov-DWR UCIP) FIELD_STRUCT_DESC: 12-inch steel irrigation pipe through the levee, 1.5 feet below the crown. Slant pump in stream. Gate valve on waterside (WS) slope. Service pole on landside (LS) shoulder. Reinforced concrete standpipe LS of the toe. (Automatic Board Order (ABO) issued as Permit No. 9146, 1973 - Pooie Ying Fong). 1-inch steel electrical conduit at the same location, at an unknown depth. [Additional Reference(s): DWR Levee Log, 2005. USACE Sacramento O&M Manual 103, June 1954, (Station ""L2"" 82+25)]. FS Date: 7/13/2018 9:33:05 AM

Butterfly valve on LS toe.

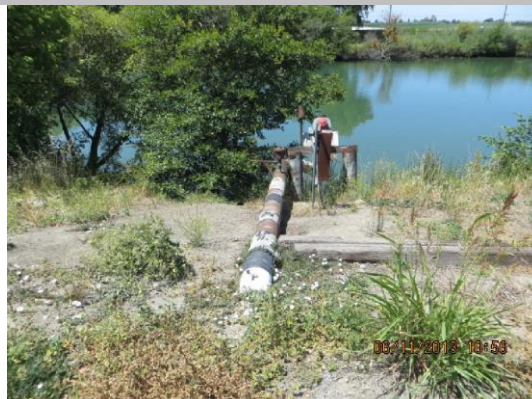
Photo 2 of 3 : UCIP_FA_2018_52753_24544.jpg

Pipe and pump on WS berm.

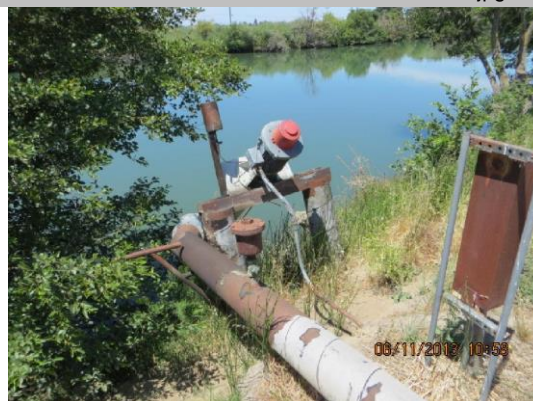
Photo 3 of 3 : UCIP_FA_2018_52753_24543.jpg

Comment Code						
Inspector Comment						
FS_ID:52753 DS_ID:20138 EP_NO: 9146 Repair Type: Non-Urgent Crossing Status: Found UCIP Comments: 07/13/2018 LS levee slope was disturbed to install a closure device and never backfilled. Debris of broken concrete and PVC pipe on LS slope. (O.Yakimov-DWR UCIP) FIELD_STRUCT_DESC: 12-inch steel irrigation pipe through the levee, 1.5 feet below the crown. Slant pump in stream. Gate valve on waterside (WS) slope. Service pole on landside (LS) shoulder. Reinforced concrete standpipe LS of the toe. (Automatic Board Order (ABO) issued as Permit No. 9146, 1973 - Pooie Ying Fong). 1-inch steel electrical conduit at the same location, at an unknown depth. [Additional Reference(s): DWR Levee Log, 2005. USACE Sacramento O&M Manual 103, June 1954, (Station ""L2"" 82+25)]. FS Date: 7/13/2018 9:33:05 AM

Pump and siphon breaker on WS berm.

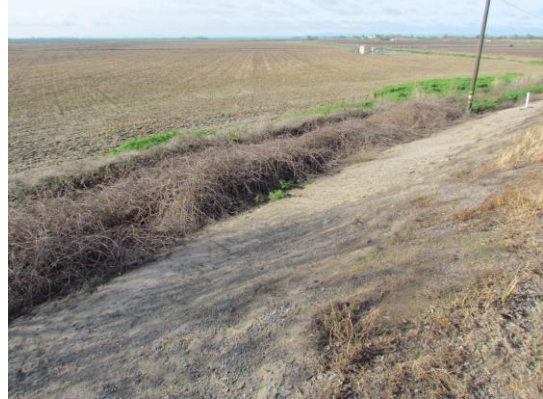
Photo 1 of 2 : FA_2018_RD0563_210_67_20180925_00024.jpg

Looking east at dead berryvines at landward toe. (Spring 2017)

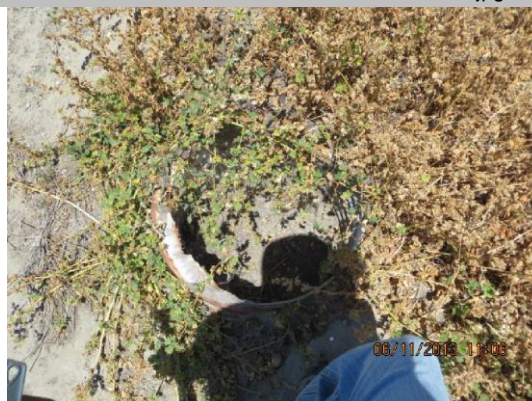
Photo 1 of 3 : UCIP_FA_2018_52754_24548.jpg

Comment Code					
Inspector Comment					
FS_ID:52754 DS_ID:20139 EP_NO: N/A Repair Type: Non-Urgent Crossing Status: Found UCIP Comments: 07/13/2018 Unable to locate siphon breaker and CMP riser on LS due to heavy vegetation. (O.Yakimov-DWR UCIP)06/11/2013 Abandoned and should be done so properly. Need to verify disposition of pipe. FIELD_STRUCT_DESC: *ABANDONED* 6-inch steel pipe of an unknown purpose through the levee, 4 feet below the crown. Siphon breaker in a 24-inch corrugated metal pipe (CMP) riser on the landside (LS) shoulder. Open on both ends. [Additional Reference(s): DWR Levee Log, 2005. USACE Sacramento O&M Manual 103, June 1954, (Station ""L2"" 62+79) 1-inch air valve, brass cock and cover]. FS Date: 7/13/2018 9:42:58 AM

24-inch CMP standpipe on LS slope.

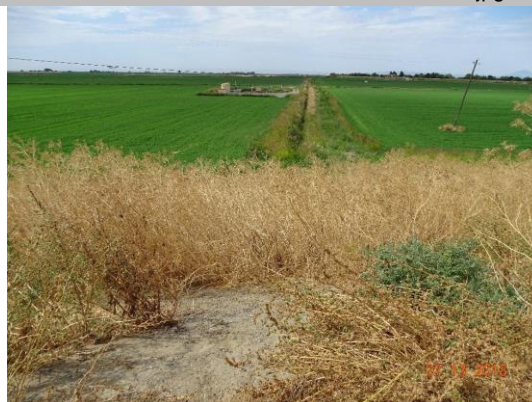
Photo 2 of 3 : UCIP_FA_2018_52754_77743.jpg

Vegetation on LS.

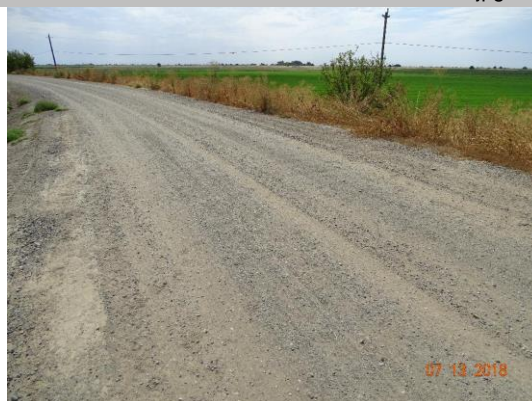
Photo 3 of 3 : UCIP_FA_2018_52754_77744.jpg

View of levee crown at the crossing.

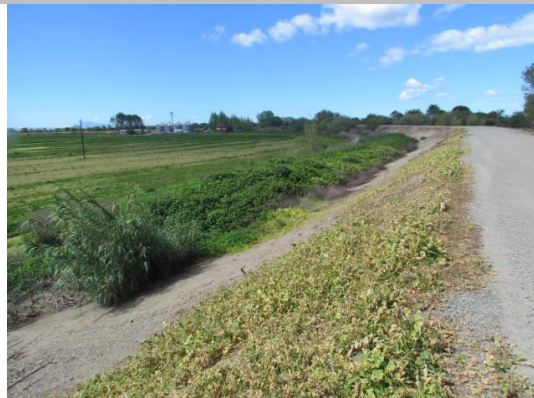
Photo 2 of 5 : FA_2018_RD0563_210_74_20180925_00034.jpg

LM Start	3.02	Rating **	M	Issue No.	74
LM End	3.21	Issue Type +	Ma	Location *	LS
Category	Earthen Levee			GPS Latitude/Longitude	
				Start	End
Item	Vegetation			38.210212 °	38.209165 °
				-121.536728 °	-121.539920 °
DWR ID	DWR_RD0563_01_s_2012_74				
Comment Code					
V2 : Remove the wild growth other than native grasses from the levee slopes.					
Inspector Comment					
Dead berryvines and dense vegetation at landside toe blocking view of toe.

Looking southeast at berryvines at landward toe., (Spring 2016)

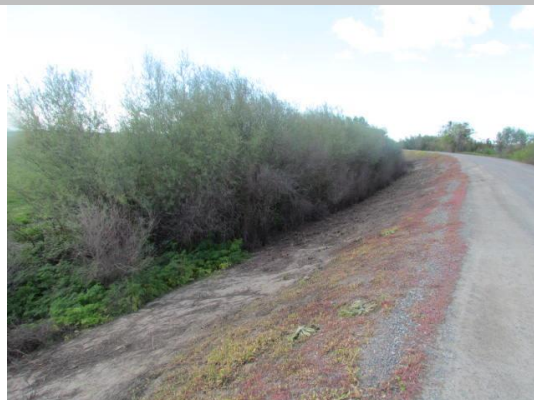
Photo 3 of 5 : FA_2018_RD0563_210_74_20180925_00035.jpg

Looking south at dense vegetation (willows) at landward toe. (Spring 2016)

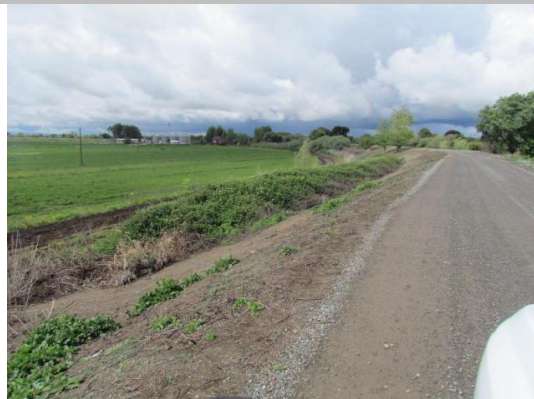
Photo 4 of 5 : FA_2018_RD0563_210_74_20180925_00036.jpg

Looking southeast at dense berryvines at landward toe. (Spring 2015)

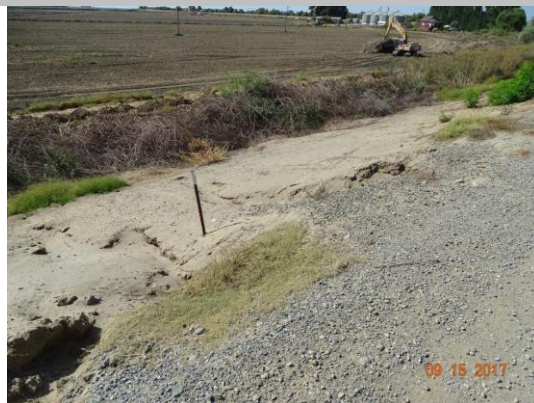
Photo 1 of 5 : FA_2018_RD0563_210_78_20180925_00043.jpg

LM Start	3.06	Rating **	U	Issue No.	78
LM End	3.06	Issue Type +	Ma	Location *	LS
Category	Earthen Levee			GPS Latitude/Longitude	
				Start	End
Item	Slope Stability			38.210240 °	38.210240 °
				-121.537517 °	-121.537517 °
DWR ID	DWR_RD0563_01_s_2012_78				
Comment Code					
S1 : Repair slope instability.					
Inspector Comment					
Slope damage on landside shoulder and slope has been in place for several inspection cycles. Proper drainage should be provided to prevent further erosion, and erosion should be repaired.

Looking southwest at the landside slope.

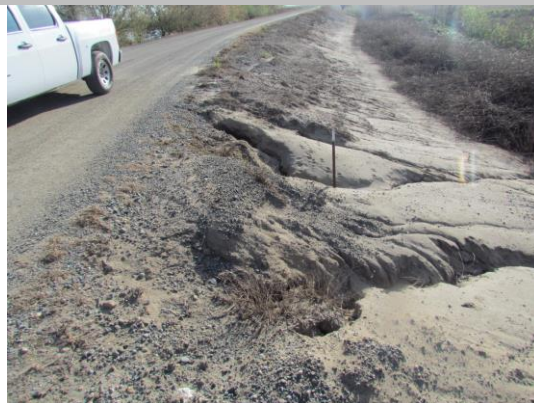
Photo 2 of 5 : FA_2018_RD0563_210_78_20180925_00044.jpg

Looking north at rain runoff erosion on landward slope. (Spring 2017)
